Impact of Darkness and Weather on Air Operations in SEA

10 MARCH 1969

HQ PACAF

DOTEC-69-16

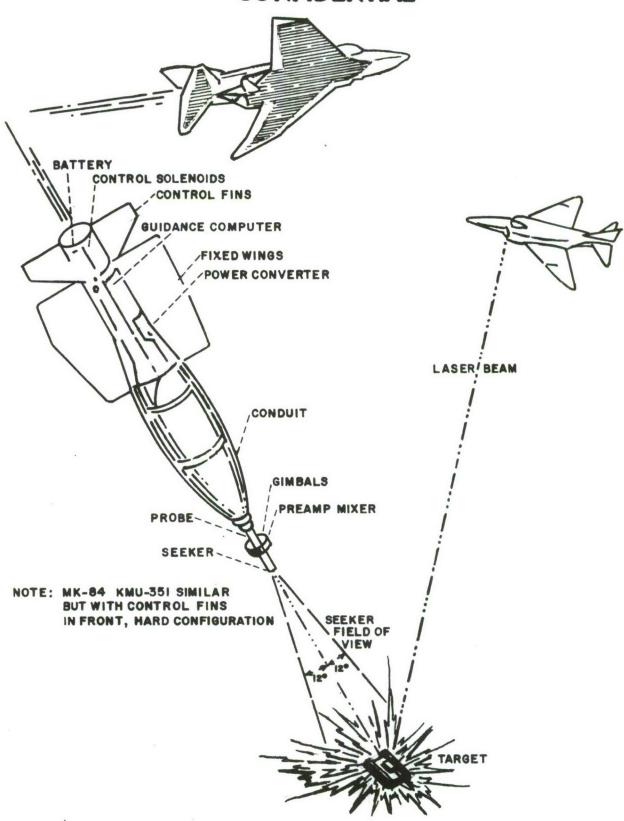
M417 GUIDED BOMB, FUNCTIONAL DIAGRAM

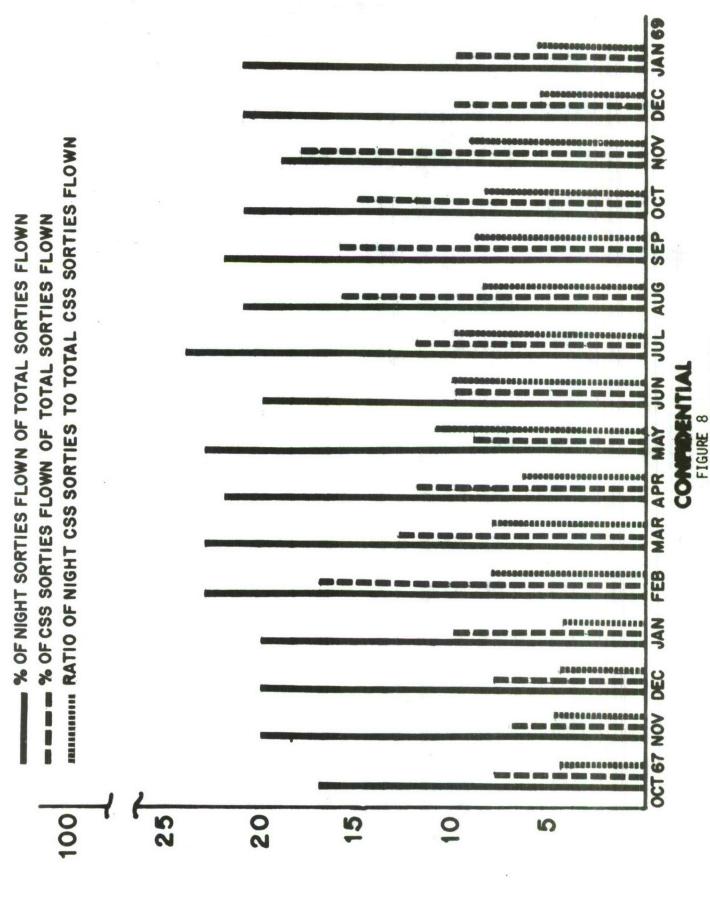
TOTAL IN 8 OUT-COUNTRY SORTIES (PERCENTAGES)

To obtain an idea of just how much emphasis was being placed on CSS missions, and also to determine approximately how much of the total strike effort was devoted to nighttime operations, a computer run was made using random samples of data compiled for the period of 1 October 1967 through 11 January 1969. For the purpose of this study, total (USAF) strike

sorties included close air support, direct air support, interdiction and armed recon missions, flown in-country and out-country and during daylight and darkness. The results of this study are shown in Figure 8. For the month of October 1967, these results indicated that out of the total sorties flown, approximately 17 percent were flown at night, while eight percent of the total flown were COMBAT SKYSPOT sorties, both day and night. Of the total CSS sorties flown, approximately 57 percent (not to be read from the ordinate scale) were flown at night. The highest percentage (24 percent) of night sorties were flown in July 1968. During the same month, 12 percent of the total sorties flown were COMBAT SKYSPOT. Of the total CSS flown, approximately 76 percent were flown at night. Although the findings of this study could not be considered conclusive evidence, they did indicate that considerable emphasis was indeed being placed upon CSS missions.
